APTB 09/16

SUBJECT: 6.4L Power Stroke®/MaxxForce® 7 High-Pressure Fuel Pump Connectors

July 11, 2016

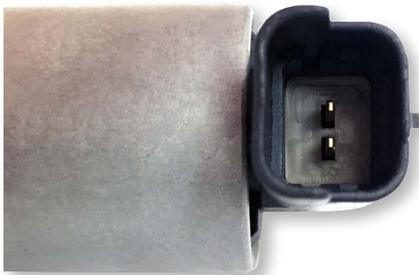
Early production pumps were equipped with rubber connector spacers in the cavity of the VCV and PCV connectors, see images below. These spacers must be removed and discarded prior to plugging in the harness connectors. If these spacers are not removed the harness connectors may not lock in place properly, resulting in possible fault codes and low power concerns.

Connector with Spacer Installed

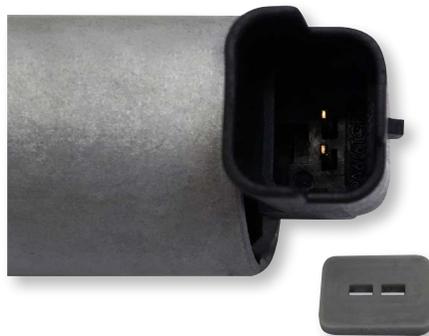
Connector with Spacer Removed

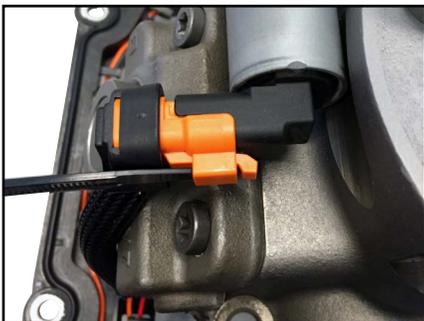
Two tie straps are supplied with all high-pressure fuel pump installation kits. These tie straps must be installed on the VCV and PCV harness connectors prior to reinstalling the high-pressure fuel pump cover. The purpose of these tie straps is to keep the harness connectors locked in place. It is an indication that the harness connector is not fully engaged and locked if the tie strap cannot be inserted through the harness connector slot, see images below.

**Connector Not Fully Engaged/
Locked**

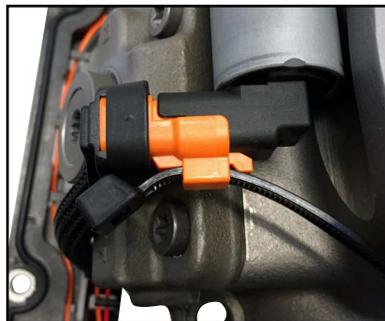
**Connector Locked with Tie Strap
Inserted**

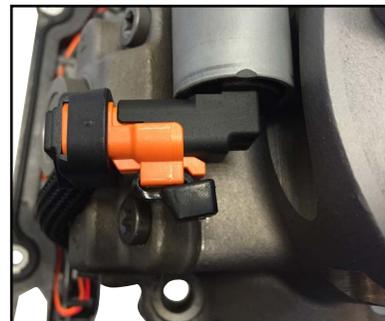
**Connector Locked with Tie Strap
Secured**
